SERVICE REPORT WITH PICTURES

Name of Ship:	CORDELIA	Date:	20/07/2018-16/08/2018
Servcies:	ME OVERHAUL SERVICE , TYPE: 7K80MC-C

As per the requirement of ship's owner (Ahrenkiel Steamship GmbH & Co. KG), arranged technicians to join the ship when she calling COSCO GUANGZHOU SHIPYARD to carry out the ME overhaul service.

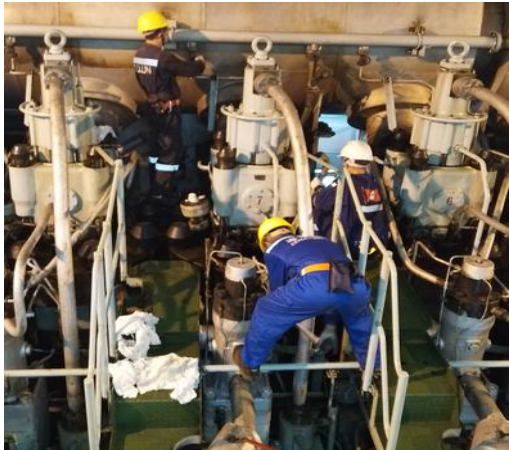
Dismantled & removed all attached pipe lines.	No.1 & No.3 unit cylinder
2

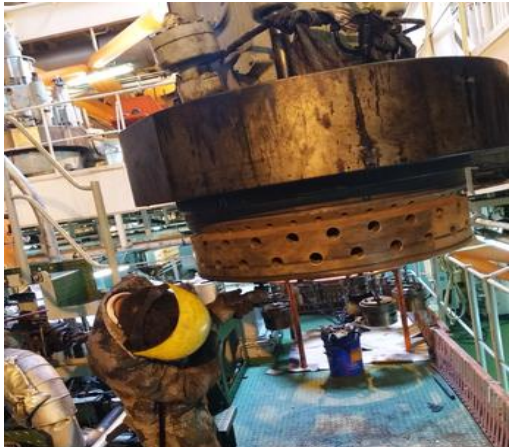
Lifted out the cylinder head & removed the cooling water jacket for cleaning.

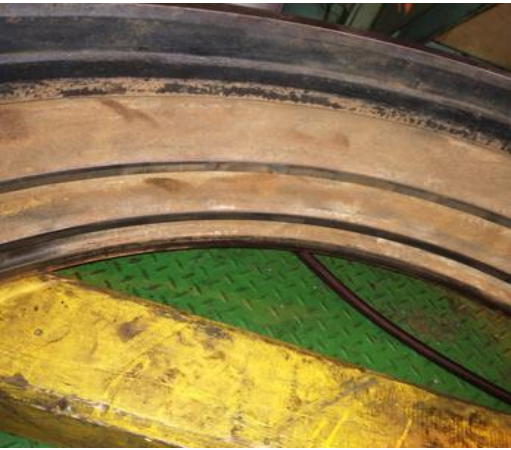
Cleaned the cooling water jacket.	
4

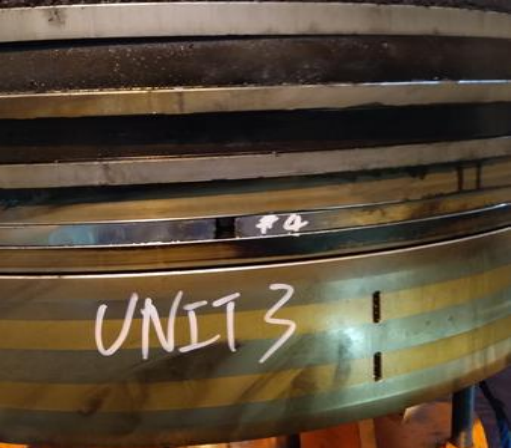
No.3 unit #4 piston ring broken.	unit 3
5

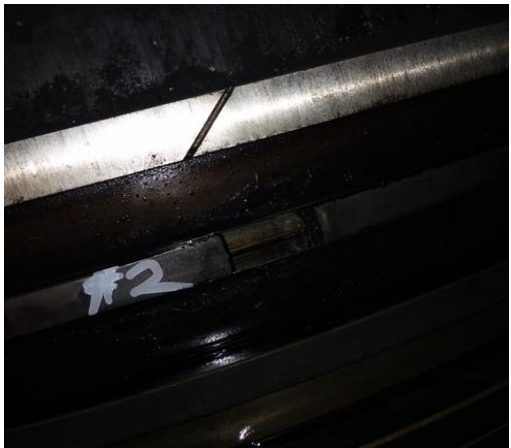
No.3 unit #2 piston ring broken.	unit 3
6

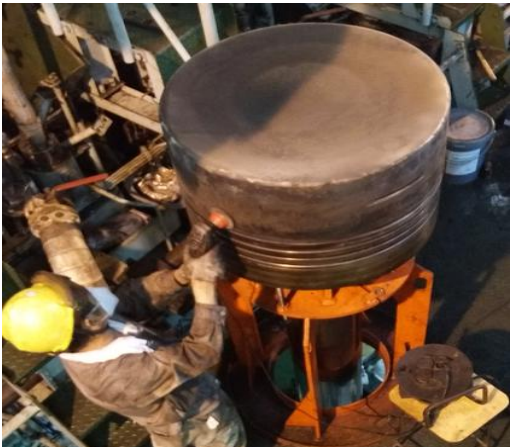
<ol style="list-style-type: none"> 1. Cleaned the piston properly. 2. Measured the piston groove, and the measurements were overlimit. 	unit 3 (regarding unit #1, the measurements were inside limit. And just cleaned & fitted back)

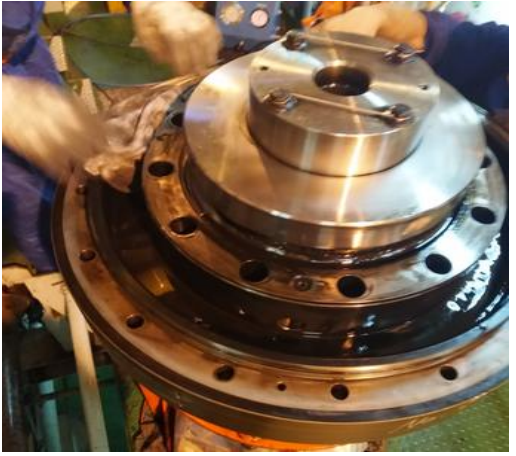
Disassembled the piston crown.	unit 3
8

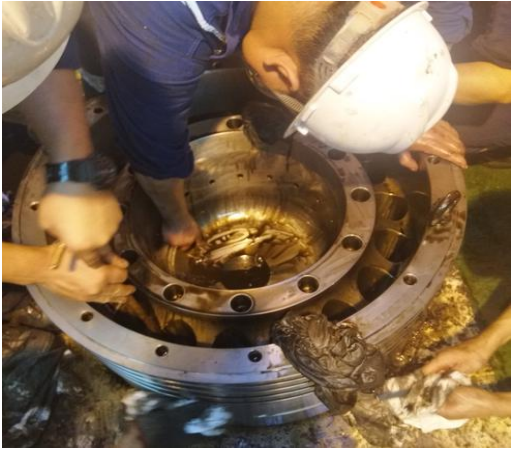
Cleaned the new piston crown.	unit 3
9

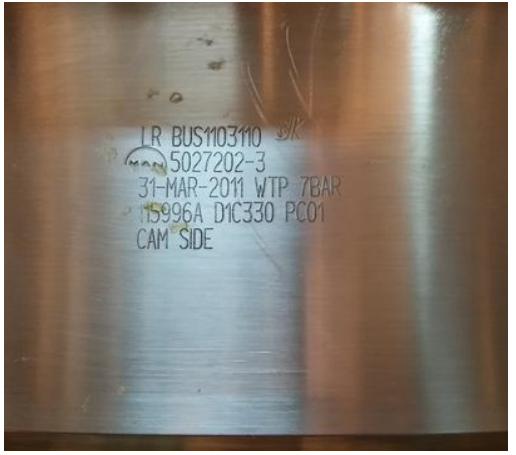
The mark of new piston crown.	unit 3
10

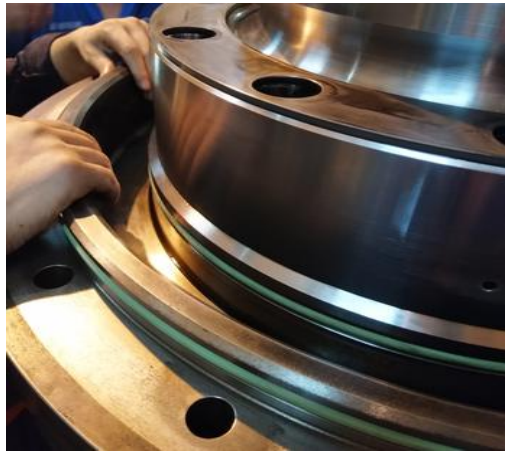
Cleaned & changed the D-rings.	unit 3

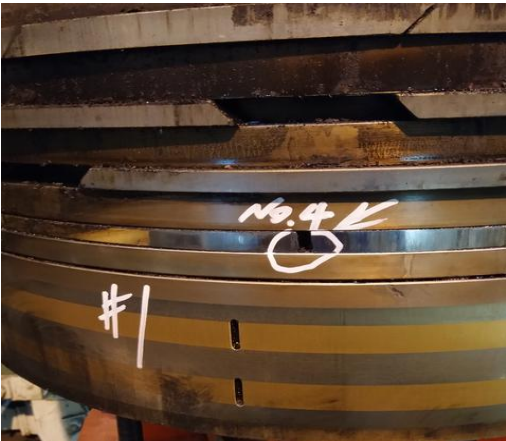
The #4 piston ring of unit 1 was broken.	unit #1
12

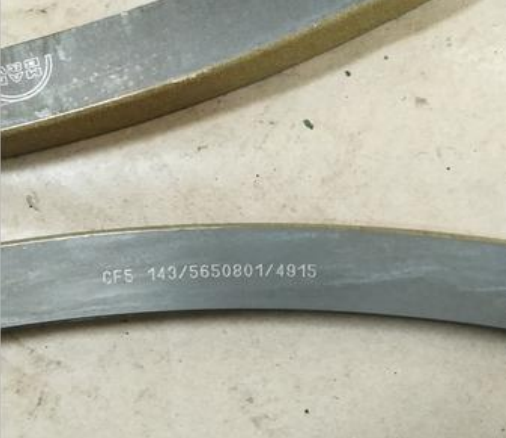
The mark of new piston ring.	
13

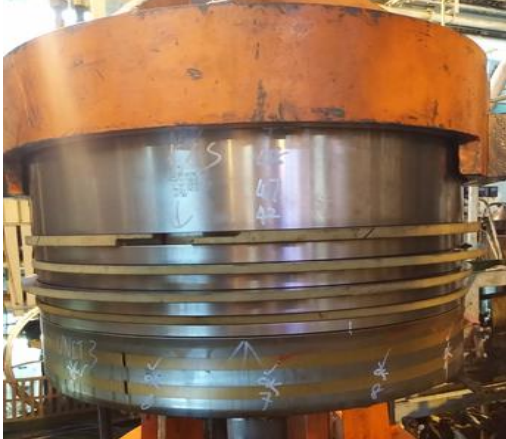
<ol style="list-style-type: none"> 1. Assembled new piston crown. 2. Pressured test of piston by 5 bar. 3. Changed to new piston rings. 	
14

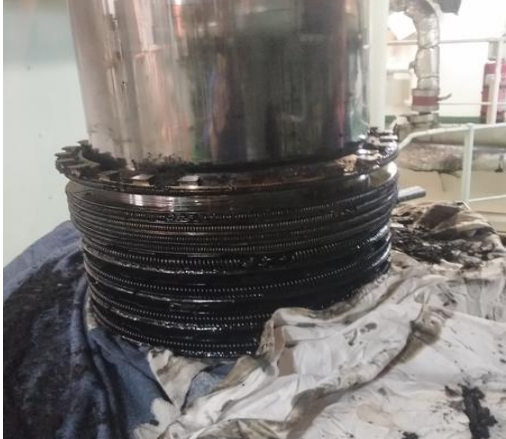
Disassembled the stuffing box for overhaul.	only for unit 3

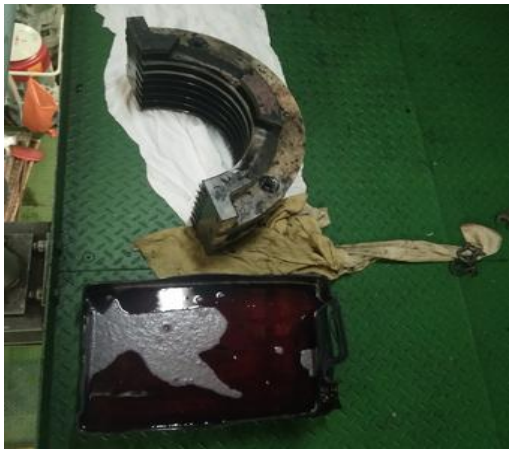
Cleaned all parts by using clean D.O	only for unit 3
16

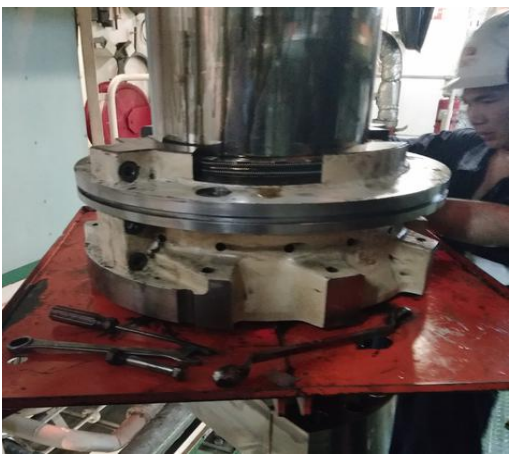
Assembled the stuffing box after exchange the scraper ring & spring with new spare parts.	only for unit 3
17

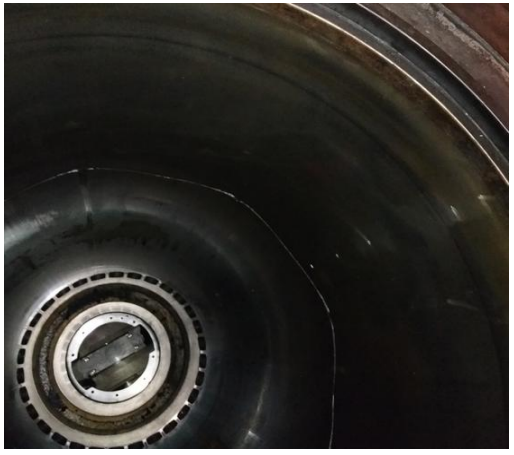
Cleaned & inspected the cylinder liner. Took measurements.	unit 1 & unit 3
18

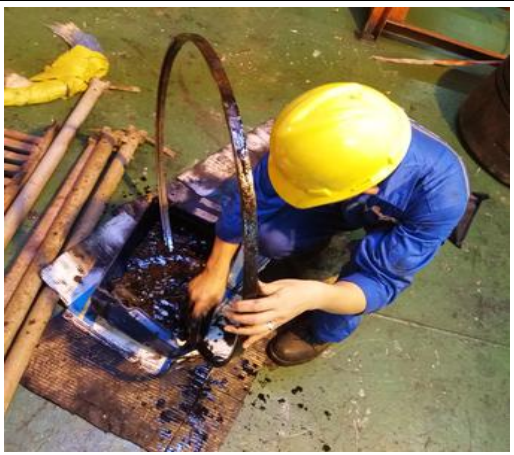
Cleaned the new fire ring.

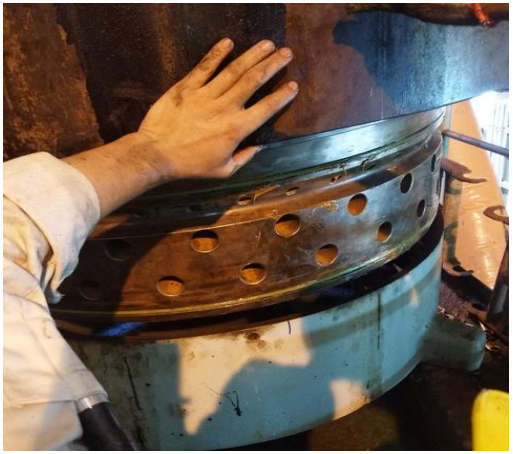
Fitted back the cleaned cooling water jacket.	
20

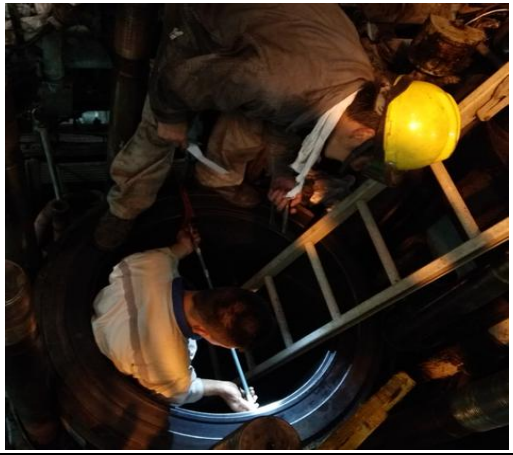
Took measurements of cylinder liner.	
21

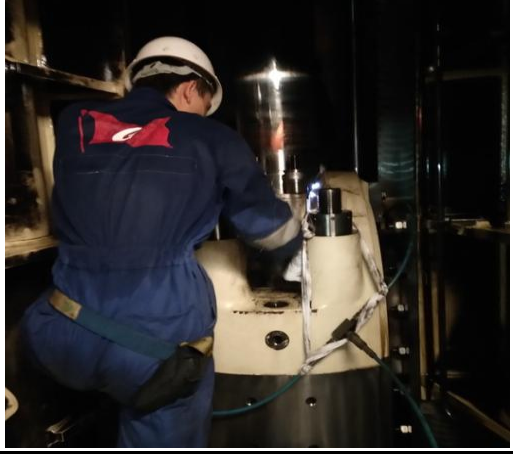
Loosen the piston rod & upper cover of crosshead.	crosshead bearing shell renewal.
22

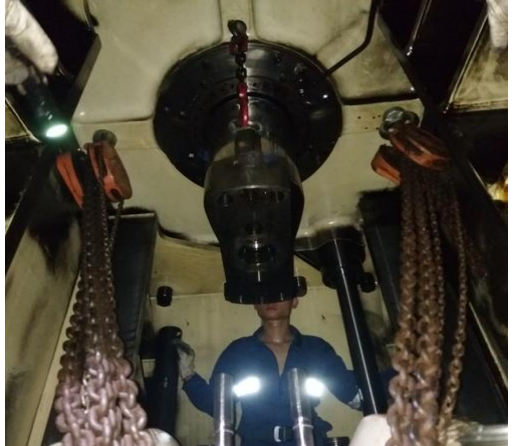
Secured the piston rod to A-frame by using special tools.	crosshead bearing shell renewal.

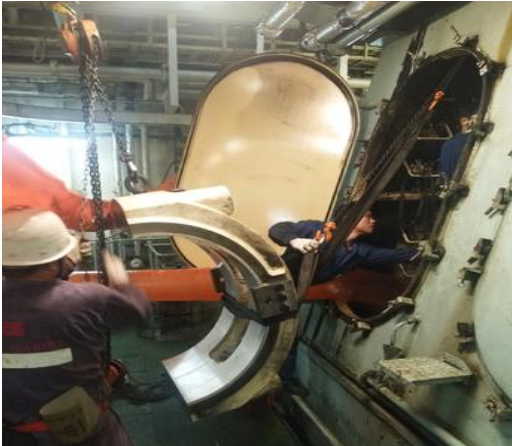
Shifted out the upper cover of crosshead.	crosshead bearing shell renewal.
24

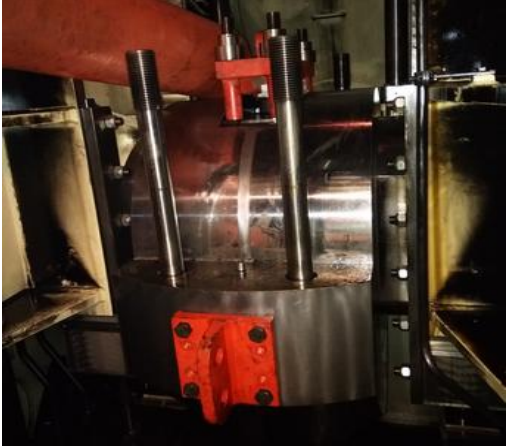
Fitted special tools.	crosshead bearing shell renewal.
25

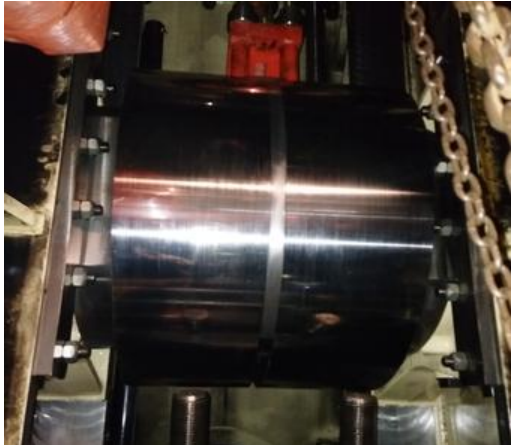
Lifted up the crosshead & secured it by using special tools & chain blocks.	crosshead bearing shell renewal.
26

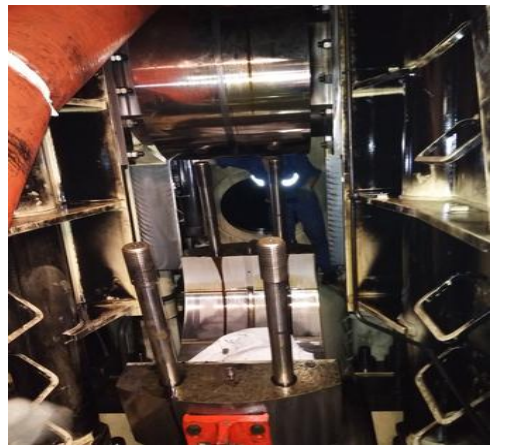
Inspected & polished the crosshead with abrasive paper for metallograph. (protect the lubricating hole by covering)	crosshead bearing shell renewal.

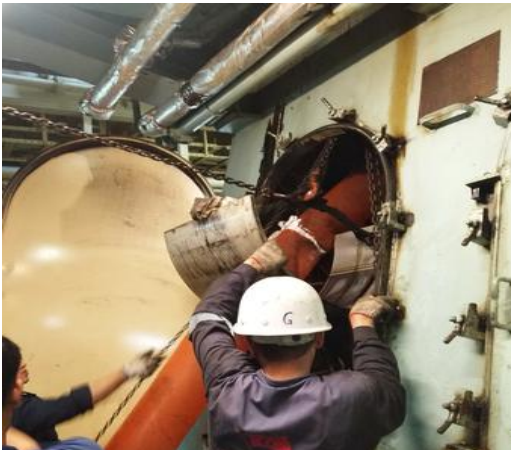
Disassembled & removed the lower bearing shell.	crosshead bearing shell renewal.
28

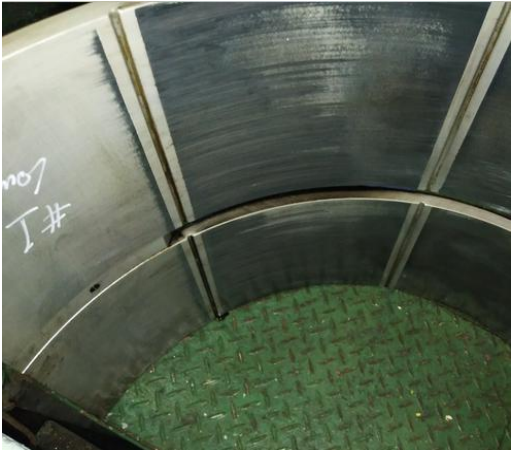
Inspected the old bearing shells.	crosshead bearing shell renewal.
29

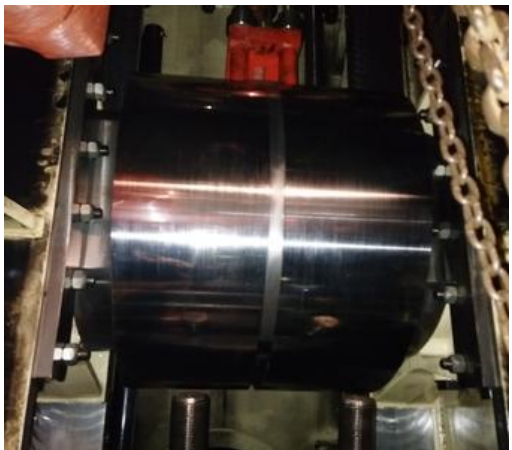
Inspected the crosshead.	crosshead bearing shell renewal.
30

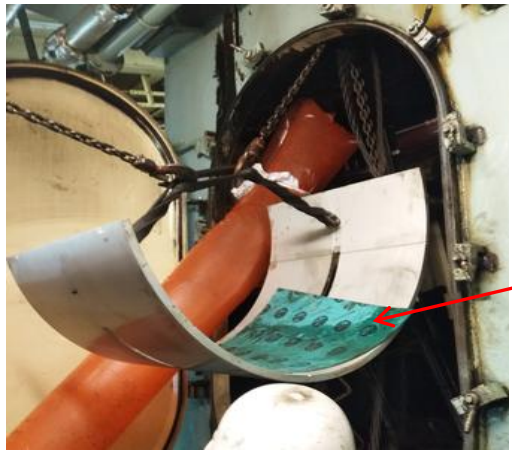
<p>Shifted the new lower bearing shell inside frame.</p> <p>To protect the shell from impact of chain.</p>	crosshead bearing shell renewal.

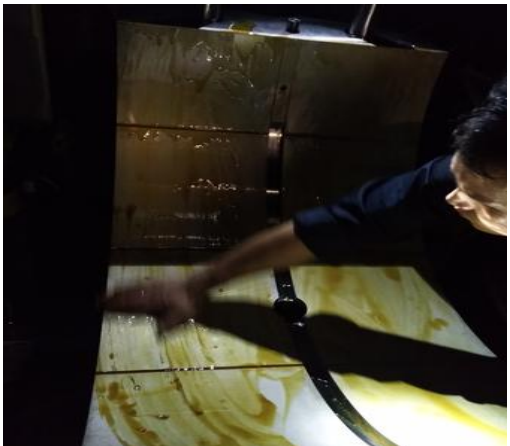
Lubricated the lower bearing shell.	crosshead bearing shell renewal.
32

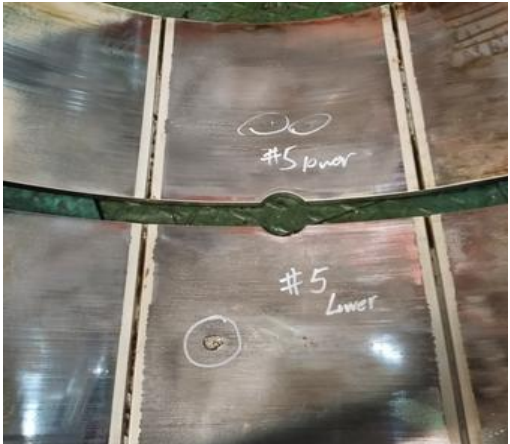
Found exfoliation of #5 lower bearing.	crosshead bearing shell renewal.
33

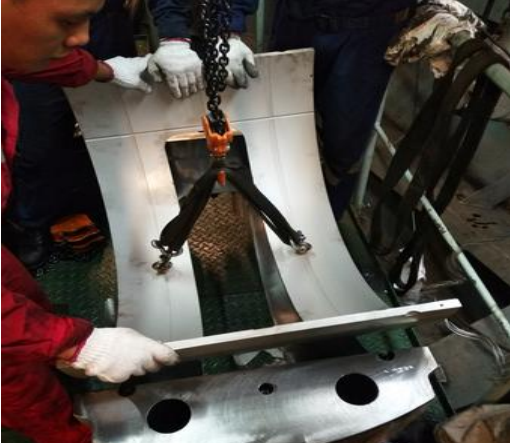
Fitted new upper bearing shell.	crosshead bearing shell renewal.
34

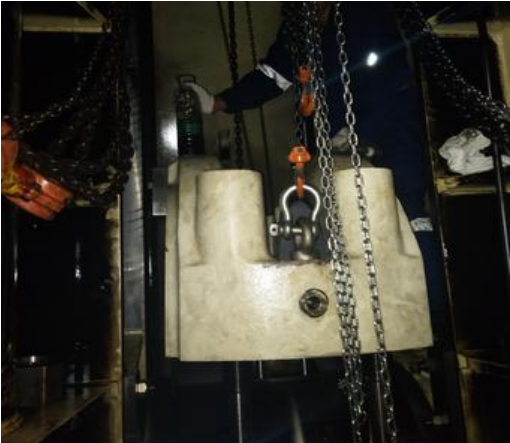
Installed the upper cover.	crosshead bearing shell renewal.

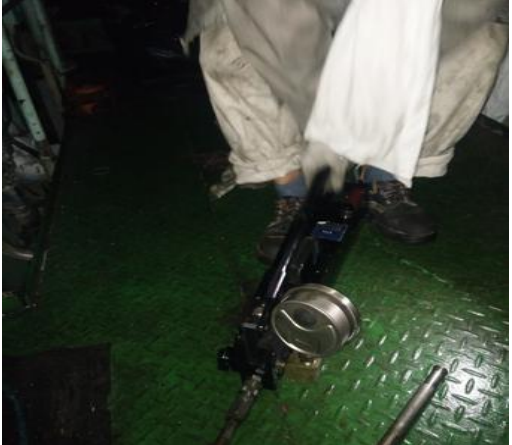
Tighten all hydraulic screws.(900bar)	crosshead bearing shell renewal.
Note:	<ol style="list-style-type: none"> 1. After completed the replacement of all crosshead bearing shells, inspected the crankcase completely. 2. Tested the ME with ship's crew, and all in normal condition. 3. All old bearing shells have been collected in wooden boxes.
