SERVICE REPORT WITH PICTURES

Name of Ship: MV GOLDEN KENNEDY Date: 13-09-2017

Servcies: Repair the jib of the provision crane

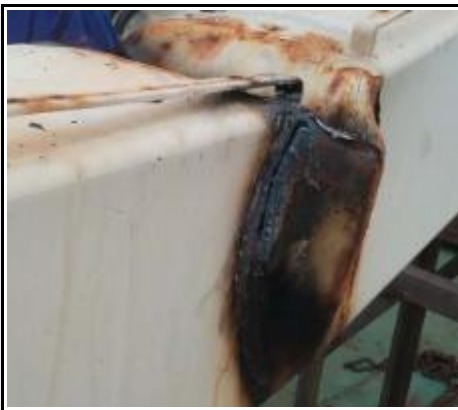
The original status of the jib

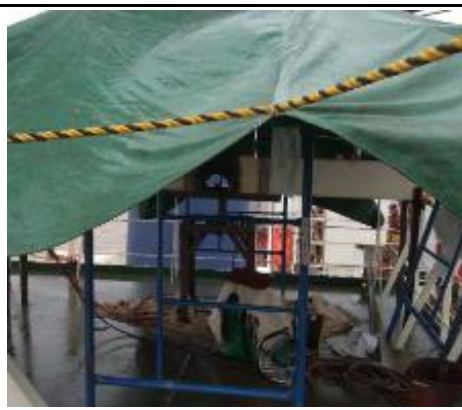
Prepared for the job

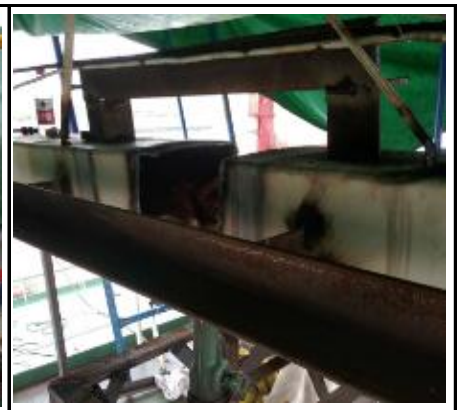
Reinforced to protect the jib from distorting

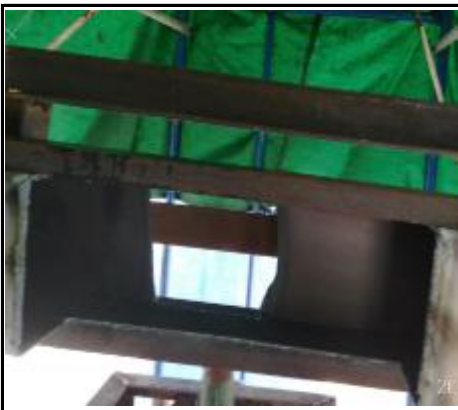
Cut the damaged area(complete by two times)

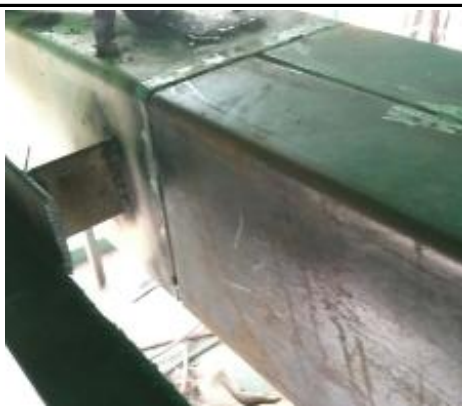
Fitted up the new material

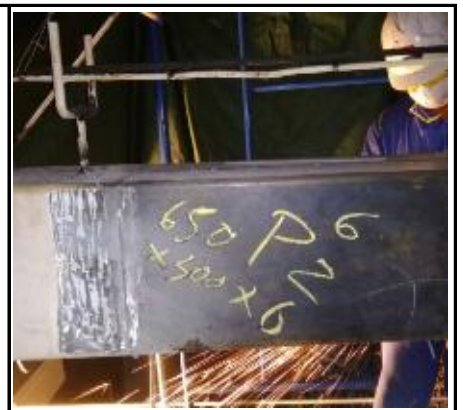
UT test after welding under the witness of ABS surveyor

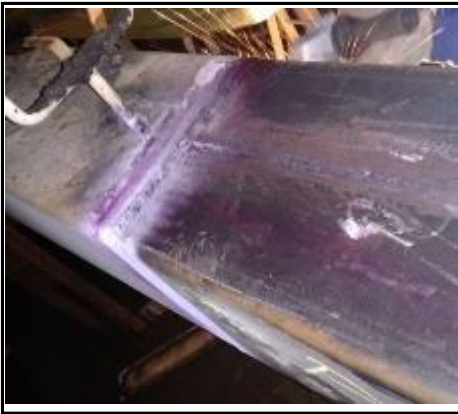
PT test after UT test under the witness of ABS surveyor

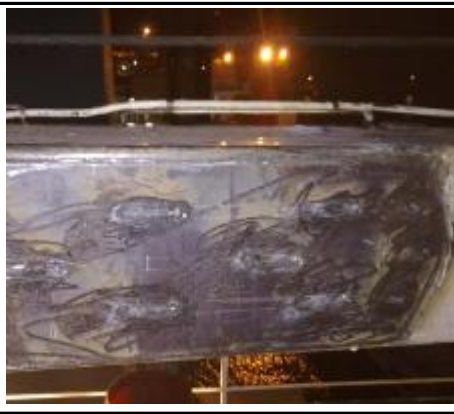
Fitted up ,welded and ground the reinforcement (double plate locating on both sides)

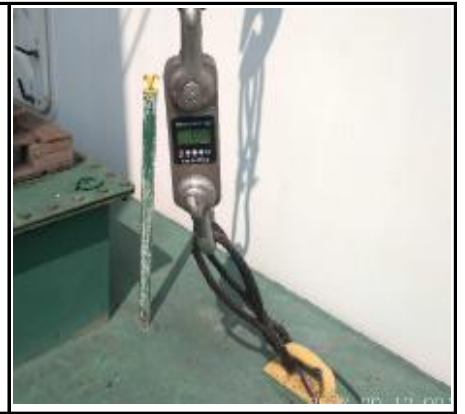
Loading test after repair (two places)

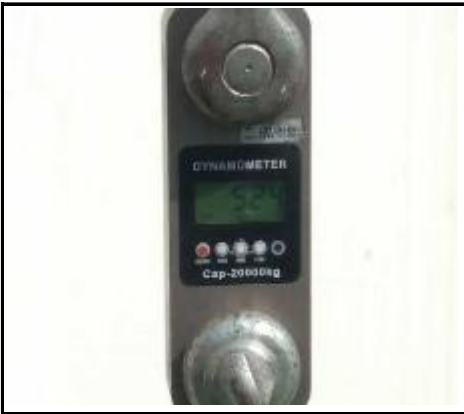
Loading test over 5 tons(the capacity of the crane is 4 tons)

The test was approved and accepted by DNVGL class surveyor with satisfaction.
